BRIXWOOD

by FEATHER HILLS

Restaurant & Wine Bar, Cabin Rentals, Concert Amphitheater in the heart of Shawnee Hills Wine Country

Overview of Brixwood

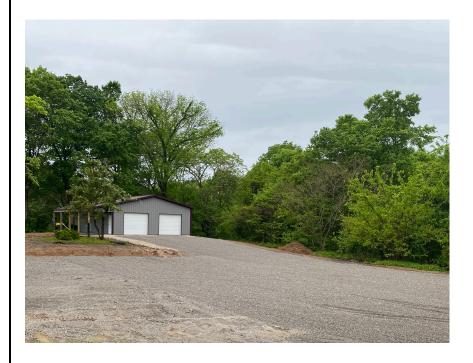
This 1200 sq foot metal building was rebuilt where the original wine production facility sat. It already has water and power but would need some further finishing/upgrades to be converted to a production facility.

Metal Outbuilding: we replaced the original wine production building (after it was condemned) with a new, 1200 square foot metal building for additional storage. It has power and water. Other information/Details: Fiberoptic High speed internet is available.

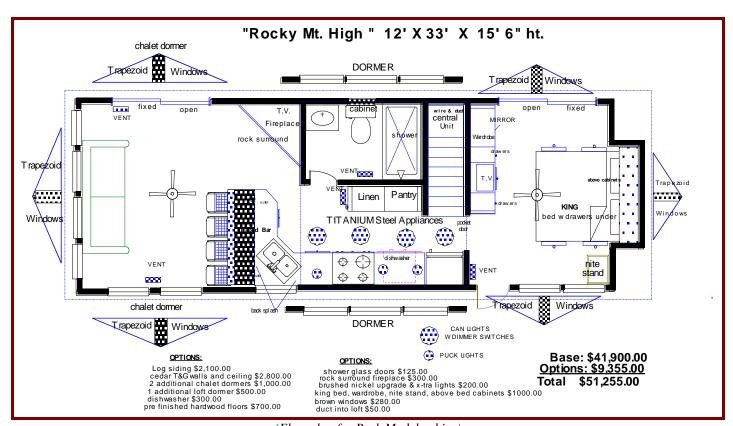
(Floorplan for Park Model cabins)

Each is 400 square feet.

1 bedroom with king size Tempur-pedic bed, full bath, full kitchen and small living room.

15' vaulted ceilings with trapezoid dormers on both ends.

180 sq ft. upstairs sleeping loft, with 3 window dormers on both sides.

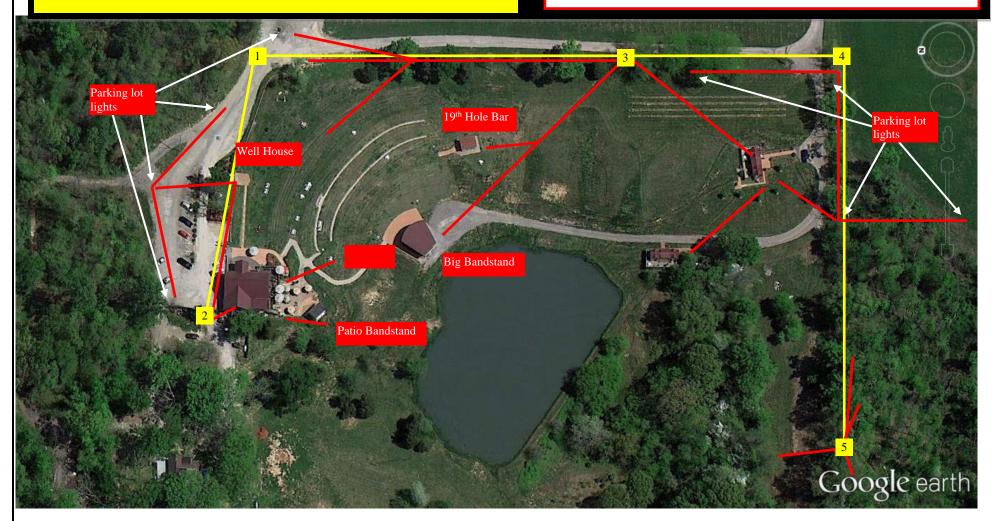
ELECTRICITY at Brixwood

#1 is main transformer coming into property from Highway 51.

#2 is ground transformer for the winery. It feeds a 1200 amp powerpanel with 6-200 amp disconnects.

#3 is ground transformer for the Big Bandstand and 2 small cabins. It feeds a 200 amp service in the bandstand, and 100 amp service in each of the cabins and in the 19th Hole Bar.

#4 is a junction box for future expansion.

#5 is a ground transformer for the 3 big cabins. It feeds an 800 amp powerpanel with 4- 200 amp disconnects.

All these lines were installed by Southern Illinois Electric Coop and are 4' deep.

The RED laterals are electric lines that WE ran from the transformers and junction boxes to various parts of the winery. These lines feed:

There are no above ground electric lines anywhere on the Winery property. We wanted to keep the visual aesthetic clear of poles and wires.

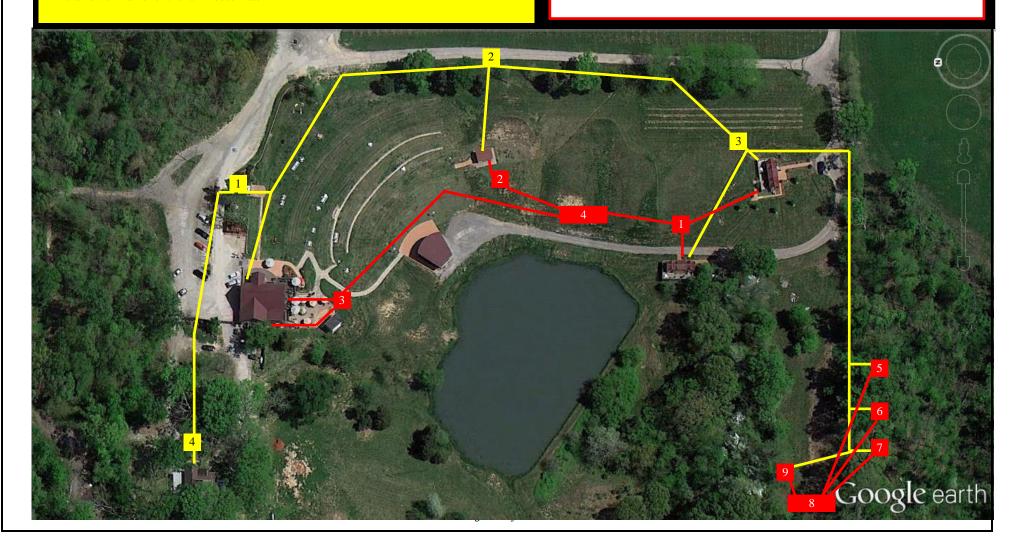
WATER at Brixwood

All yellow lines are main 1 ½" schedule 40 water lines running from the main well house to each water location.

#1 is Well House. There is a 450' deep well, with a 28 gpm variable speed pump 350' down. The well produces 4-6 gpm. Additionally, in 2021, we dug a 2nd well that produces about 18-20 gallons per minute. A large, saltwater softener system was installed in the new outbuilding for the property

#2 is an on/off valve controlling the water going to the 19th Hole Bar.

#3 is a 4 way junction and on/off valves for Cabin1, Cabin 2 and the main line going to Cabins 3,4 & 5 and the support cabin.

#4 is an on/off valve for the farmhouse water.

The RED laterals are septic lines.

#1 is the septic tank for Cabins 1 & 2.

#2 is the septic tank for the 2 bathrooms in the 19th Hole Bar.

#3 is the septic tank for the winery, with two separate lines coming from the Winery and the kitchen.

#4 is the 8'x24'12' sand pit filter system for all septic tank run off.

#5 is the septic tank for Cabin 3.

#6 is the septic tank for Cabin 4.

#7 is the septic tank for Cabin 5.

#8 is the 8'x40'12' sand pit filter system for all septic tank run off.

#9 is the septic tank for the support cabin
